NATIONAL TRANSPORTATION SAFETY BOARD

HAZARDOUS MATERIALS ACCIDENT REPORT

**HAZARDOUS MATERIALS RELEASE
FOLLOWING THE DERAILMENT OF
BALTIMORE AND OHIO RAILROAD COMPANY
TRAIN NO. SLFR
MIAMISBURG, OHIO
JULY 8, 1986**

NTSB/HZM-87/01

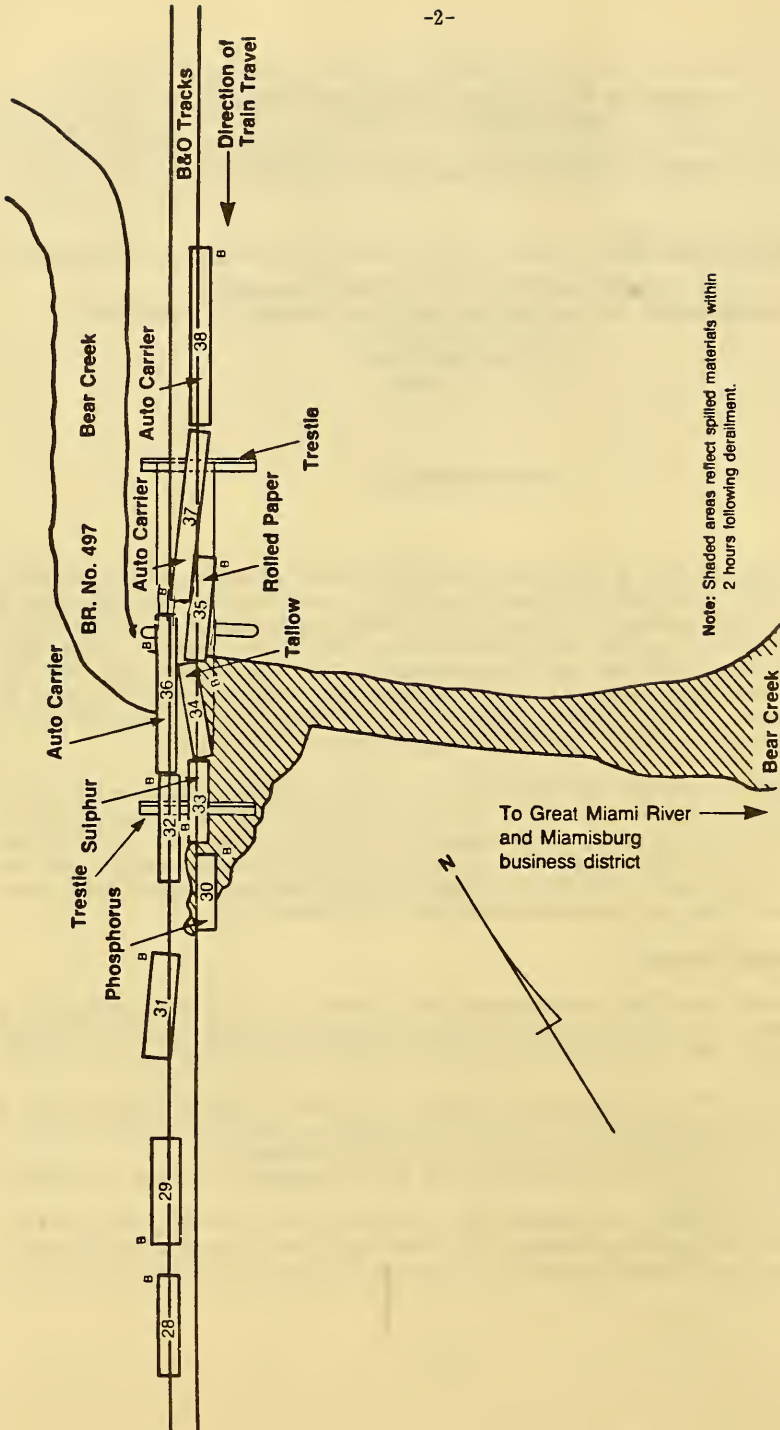
Figure 1.—Deraiment site.

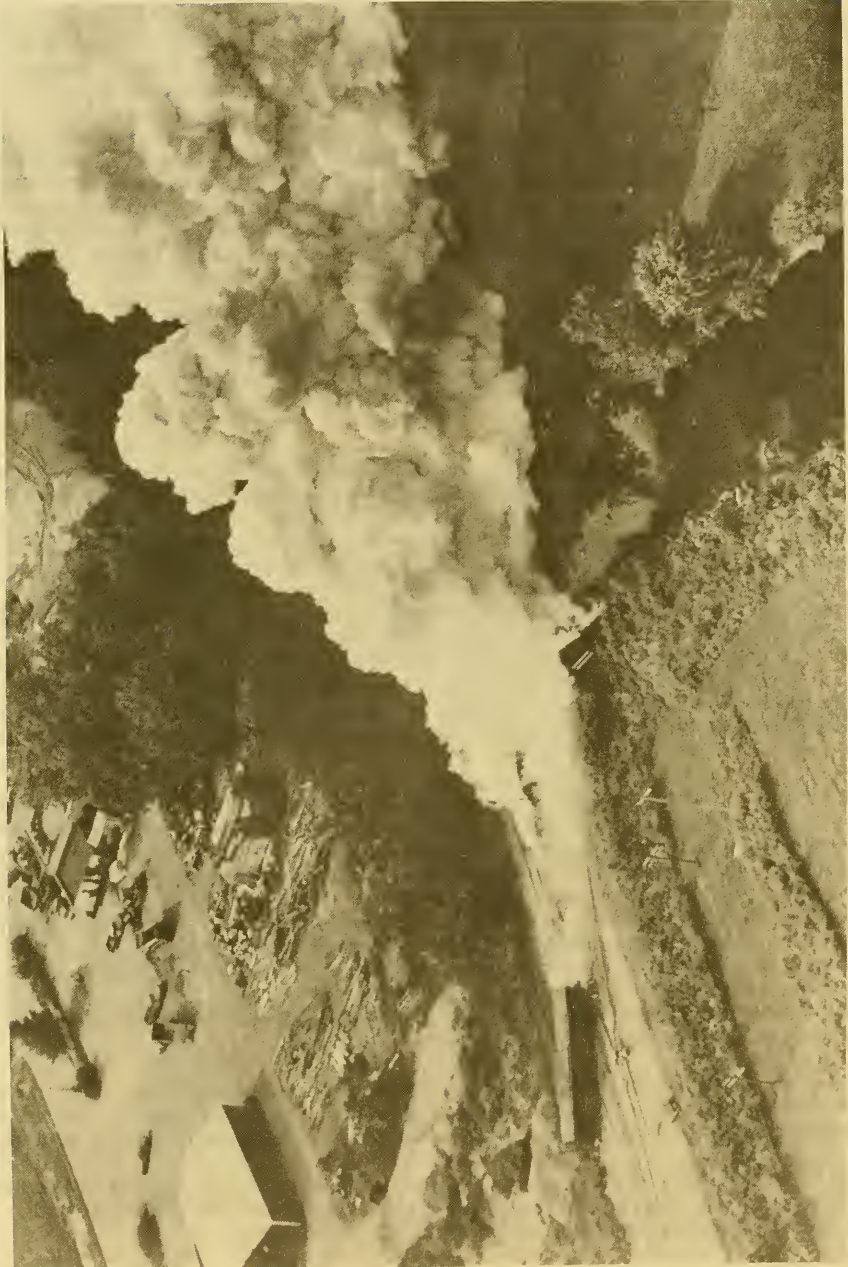
Figure 2.—Cloud viewed from the city east of the accident site.
